APPENDIX I – PRELIMINARY ENVIRONMENTAL REPORTS

As of October 2014 several environmental documents have been compiled in support of the airport development under consideration for Dickinson Theodore Roosevelt Regional Airport. The following items are included in this appendix:

Dickinson Regional Airport Master Plan – Phase II Wildlife Hazard Review and Site Visits

WETLAND DELINEATION

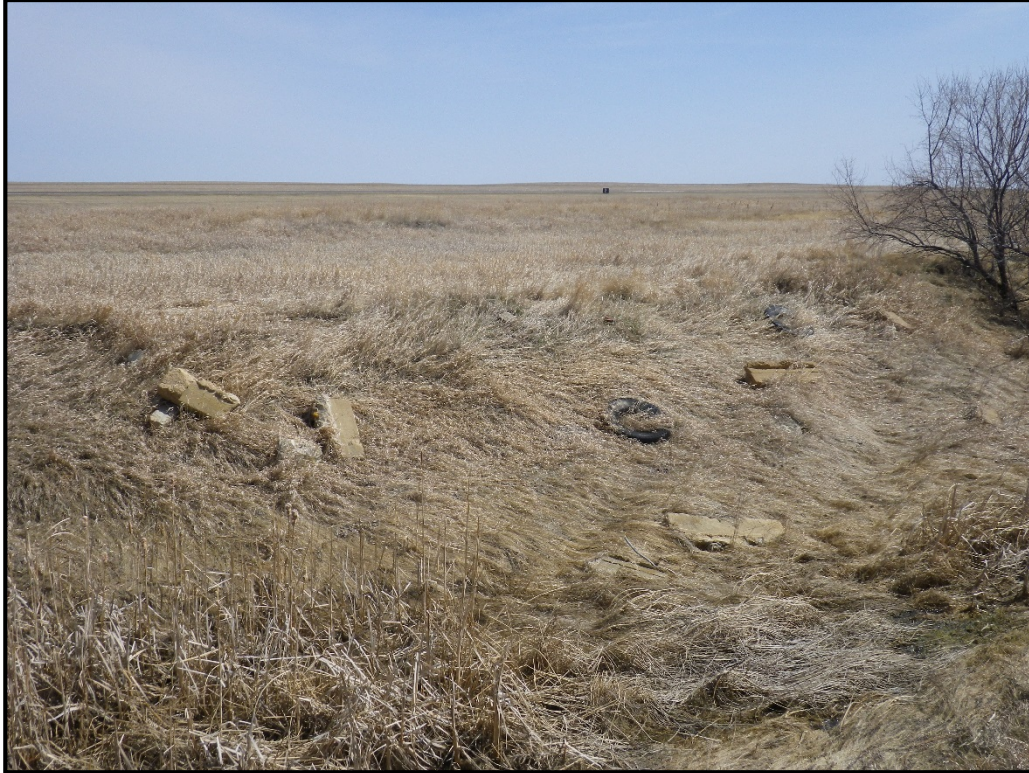
Figure 3: Overview of newly recorded portion of site 39SK988, view to the east-southeast.

A cultural material scatter containing several large pieces of concrete, rubber tires, and a piece of metal is located south of the culvert was identified and recorded during the site revisit. The concrete is possibly the remnants of a foundation or used to be part of the culvert.

Currently the site retains good integrity of location. The site was previously recommended as *Not Eligible* for the NRHP. As the site is neither unique nor is likely to provide additional information about local, state, or national history, KLJ agrees with the previous recommendation of *Not Eligible* for the NRHP and no avoidance is required.

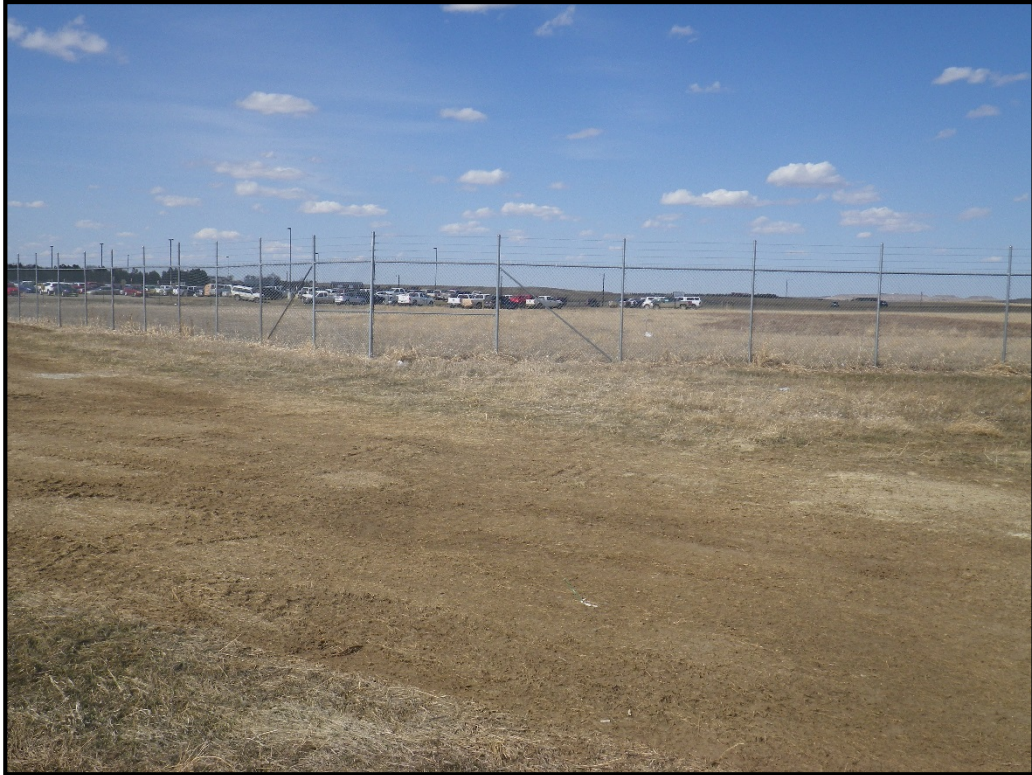
Figure 7: Overview of 32SKx377, view to the north.

Overall, 32SKx377 is recommended *Not Eligible* for inclusion to the NRHP and no avoidance is recommended.

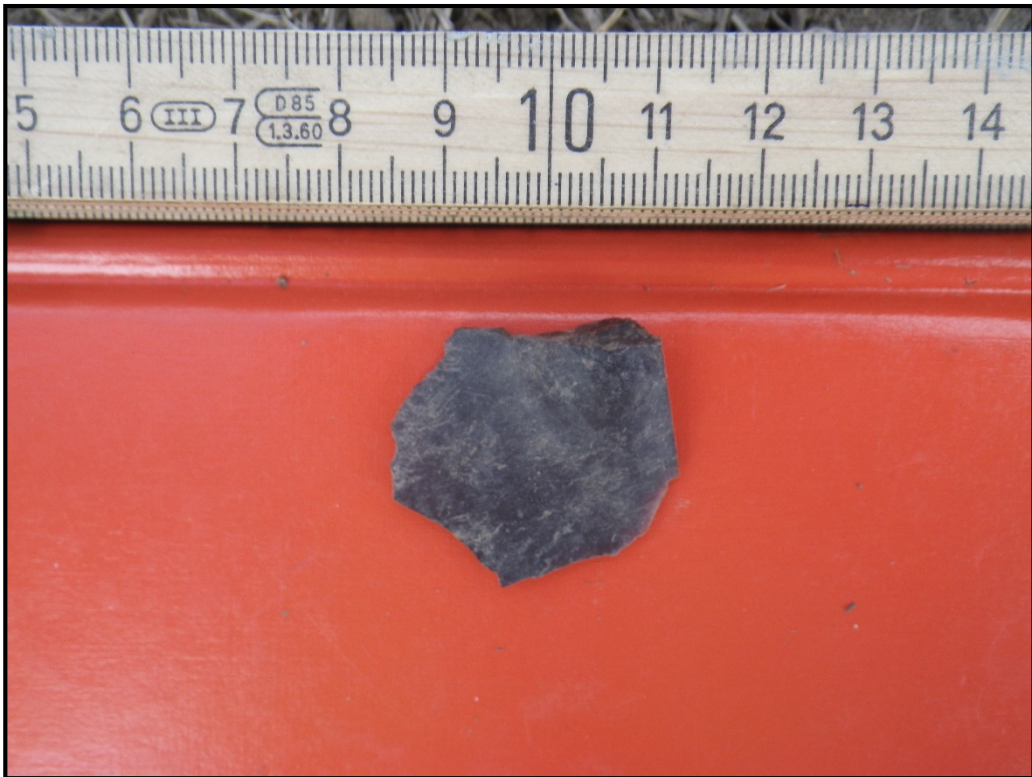
Figure 8: Ventral side of dark brown Knife River Flint flake.

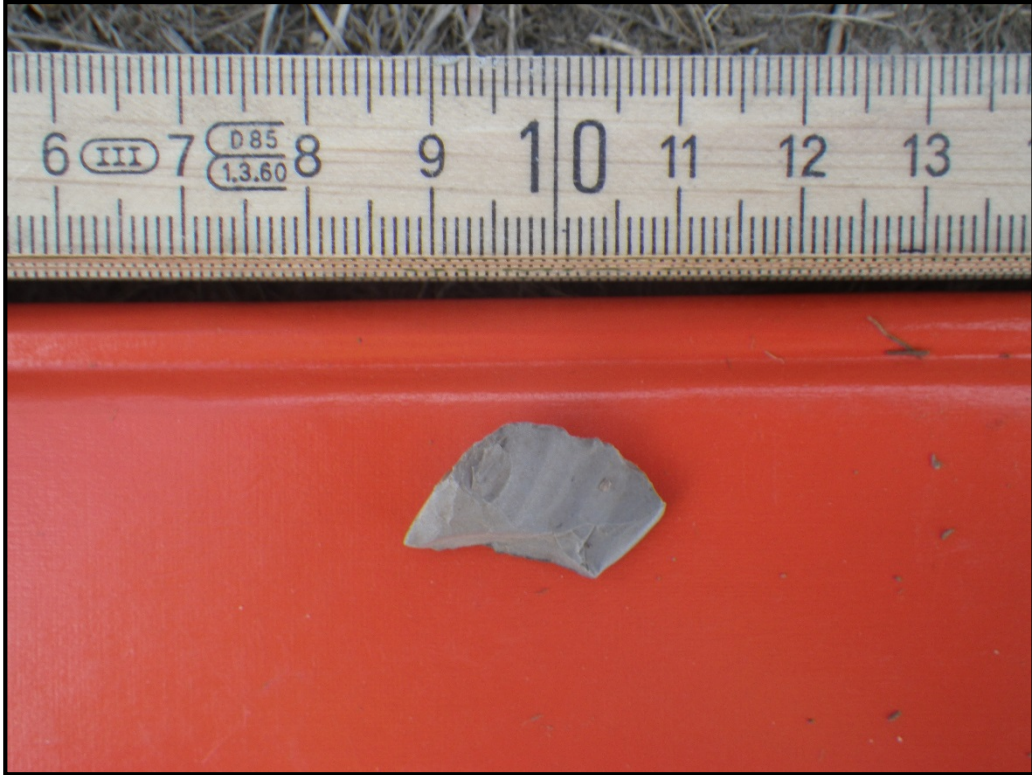
Figure 9: Ventral side of gray chert flake.

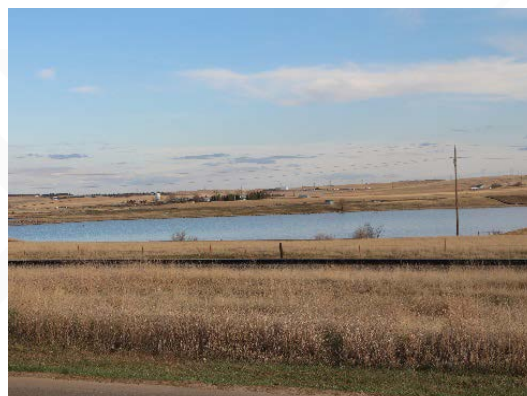
South Stock Pond. This stock dam, located on airport property, approximately 220 yards SW of the end of Runway 32 is the same stock pond identified in the 2006 WHA as posing a slight hazard threat to aircraft at DIK. This pond is fed by a drainage ditch that flows from the DIK airfield and runs somewhat beside and parallel to the 32 Runway as it flows outside of the current perimeter fence. The pond does not appear to have any wetland vegetation associated with it. It was icing over during the fall site visit but held up to 3 ducks on occasion in the spring. While this wetland does not attract a lot of waterfowl, its close proximity to the runway continues to cause a slight hazard threat to aircraft.

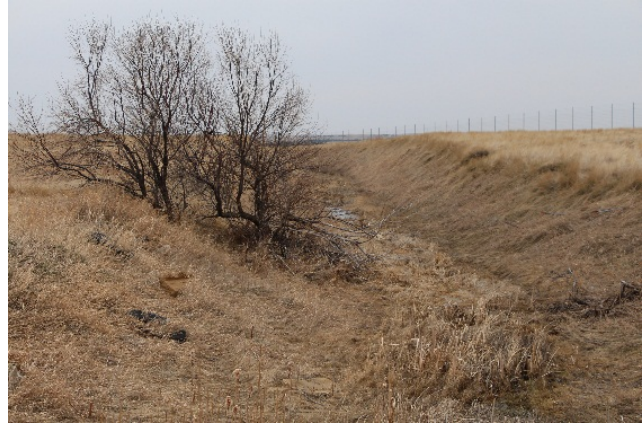
Airfield Drainage Ditch. This drainage ditch flows from under Runway 32 towards the south, somewhat parallel along the runway, and empties into the South Stock Pond discussed above. It is a fairly deep ditch or canal and contains tall grass, cattails and some open water as it maintained a small flow of water during both the spring and fall. While the water was fairly minimal, it did contain enough to attract a pair of ducks in the spring. Its significant depth provides an ample hiding area for medium sized mammals such as fox or coyotes. Along with a Russian olive tree, some minor debris (old tires, concrete rubble) and some miscellaneous stone, it could be an attractive area for fox/coyote dens, skunks, raccoon and deer should they gain access to the airfield. The overall hazard that this ditch creates at DIK is fairly minimal. However, to minimize its attractiveness, it is recommended that this ditch is modified so that the vegetation can be controlled and water flows off of the airfield as quickly as possible, without creating ponds or pools. Any trees, shrubs or debris should also be removed.

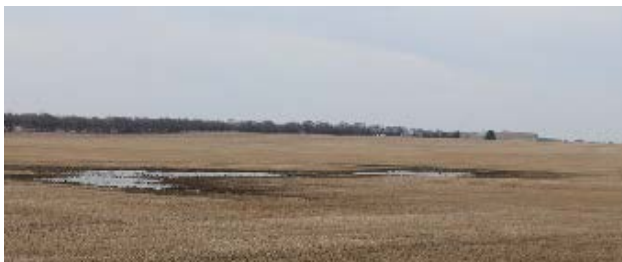
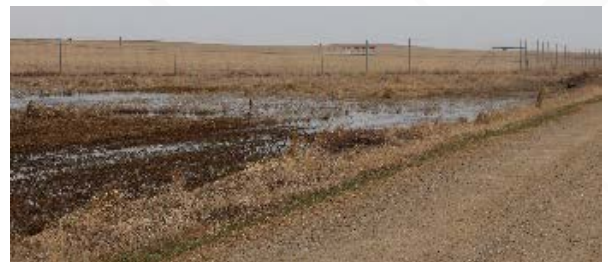
North TSW (Temporary Standing Water). During the spring site visit, considerable standing water existed in the cropland immediately north of the perimeter fence in direct line with runway 14. This created a marshy area that extended from the perimeter fence to the NW and was used by several ducks. Additional areas of temporary standing water was present immediately to the northeast, in the same field.

The temporary standing water to the north of the current airfield, identified as North TSW can attract several ducks in the spring when snow has melted and the ground is saturated. For those few weeks, this area will hold a few ducks. While the area is about 1900 feet or more from the end of the Runway 14, it does lie close (200 feet) to the flight path of planes using the main runway. Considering this long distance and brief period of activity, this is a minor hazard concern. This property is not currently owned by the airport. Should the airport ever obtain ownership of this property in the future it is recommended that these low areas be raised or drained to prevent the temporary standing water. This should eliminate the small chance of a duck strike.

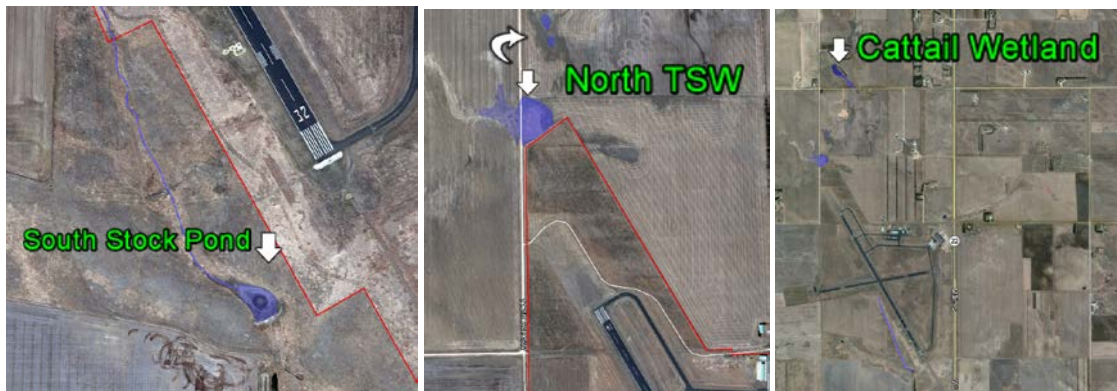
No Action. The evaluation of the No Action Alternative did not reveal any major differences from the issues discussed in the 2006 WHA. The stock pond just south of the end of Runway 32 continues to pose a minimal hazard. Since it appears to attract one or two ducks on occasion, and the fact that it lies about 700 feet from the end of the runway, it would be prudent to convert this pond to a stock tank, move it farther down the drainage, or remove it altogether. While this is a fairly small hazard, it does have the potential to cause a duck/aircraft strike.

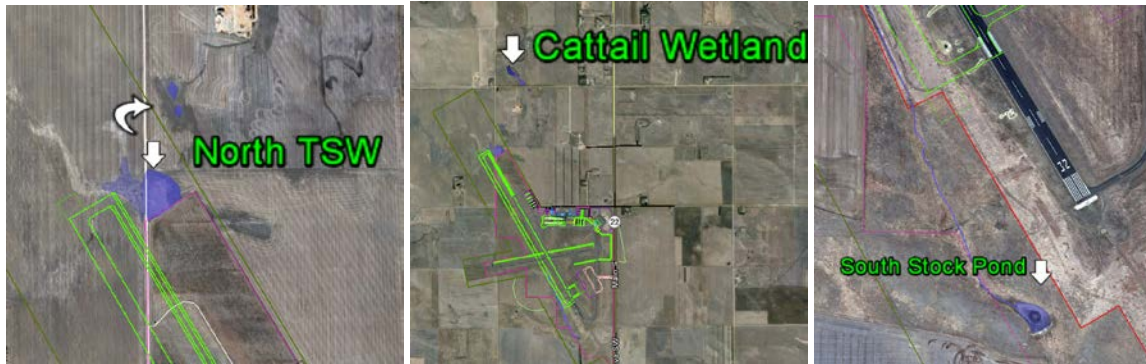
Alternative F. Since Alternative F moves the main runway to the west and extends it farther to the northwest, Runway 14 will lie about 600 feet beside the temporary wetland labeled “North TSW”. The parallel taxiway will be almost beside this wetland. Considering that this area of temporary standing water can expand during the spring runoff period, it is likely that standing water could be present very close to and right off the end of the runway, creating a fairly high hazard for a brief period of the year. The drainage of this area should be modified to eliminate the standing water in the spring. A narrow drainage ditch that can move the water out of the area more quickly & efficiently is one option.

The wetland labeled “Cattail Wetland” lies almost 4000 feet from the Runway 14 end and is almost 3000 feet from the aircraft flight path. It is therefore not considered a hazard.

From the south end of the Alternative F Runway 32, the South Stock Pond lies 1400 feet from the end of Runway 32, a much greater distance than the current runway. However, with the shift of the runway to the west, the pond will lie within 170 feet of the aircraft flight path. Considering the low duck activity on this pond, the distance from the runway, the South Stock Pond likely poses a very small threat for Alternative F. However, the same modifications as discussed above in the No Action Alternative would apply for this alternative. It would be beneficial to convert this pond to a stock tank, move it farther down the drainage, or remove it altogether.

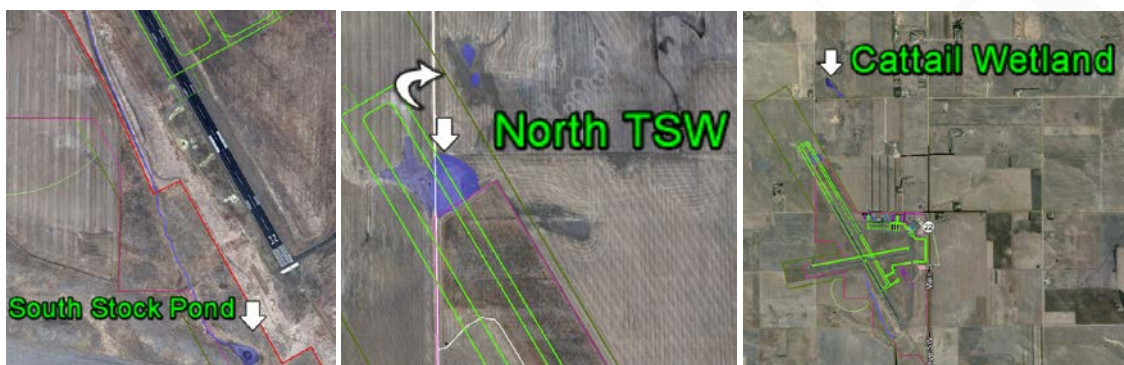
Alternative G. This alternative significantly shifts both ends of the 14/32 runway to the north. With Alternative G, the South Stock Pond lies more than 2000 feet from the end of the runway and 560 feet from the flight path (Table 1.). Considering these factors, along with the fact that few ducks use this pond, the wildlife hazards associated with pond should be extremely minimal.

On the northwest end, Runway 14 and its parallel taxiway pass directly through the temporary standing waters labeled North TSW. In Alternative G, these wetland areas that contain standing water will become part of the DIK airfield. This will pose a significant hazard during the spring months. It is likely that these low areas will likely be filled, graded and drained in the construction of the new runway.

Regardless, these wetlands are a seasonal attractant and should not become part of the DIK airfield unless their attraction to waterfowl is eliminated.

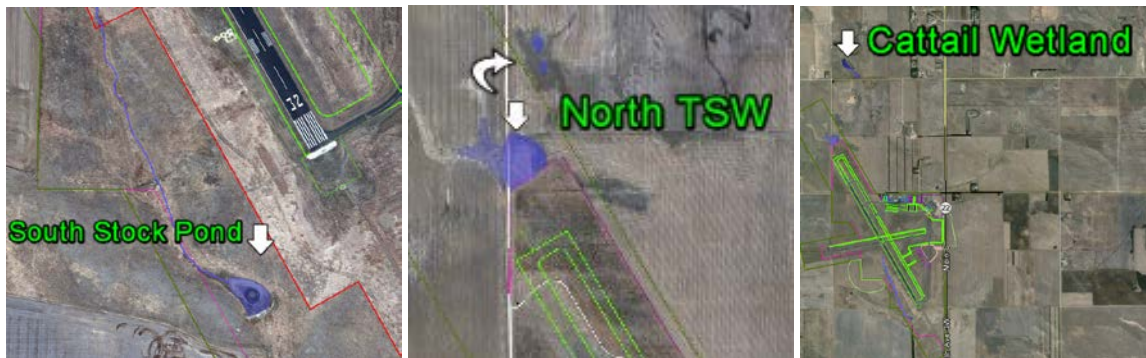
Alternative H. In Alternative H, Runway 14 is extended north approximately 1300 feet without changing the 32 end from its current location. Therefore, the issues associated with Runway 32 are the same with Alternative H as they are with the No Action Alternative. This primarily involves the proximity of Runway 32 to the South Stock Pond that lies about 700 feet from the end of the runway. While it presents a fairly small hazard, it is recommended to convert this pond to a stock tank, move it farther down the drainage, or remove it altogether.

On the Runway 14 end of Alternative H, the temporary standing water labeled “North TSW” is about 630 feet from the end of the runway and lies less than 200 feet from the flight path. While this is an attractive area for low numbers of ducks in the spring, it should be modified so that standing water is prevented.

The Cattail Wetland is about 4300 feet from the Alternative H Runway 14 and does not appear to pose a significant hazard.

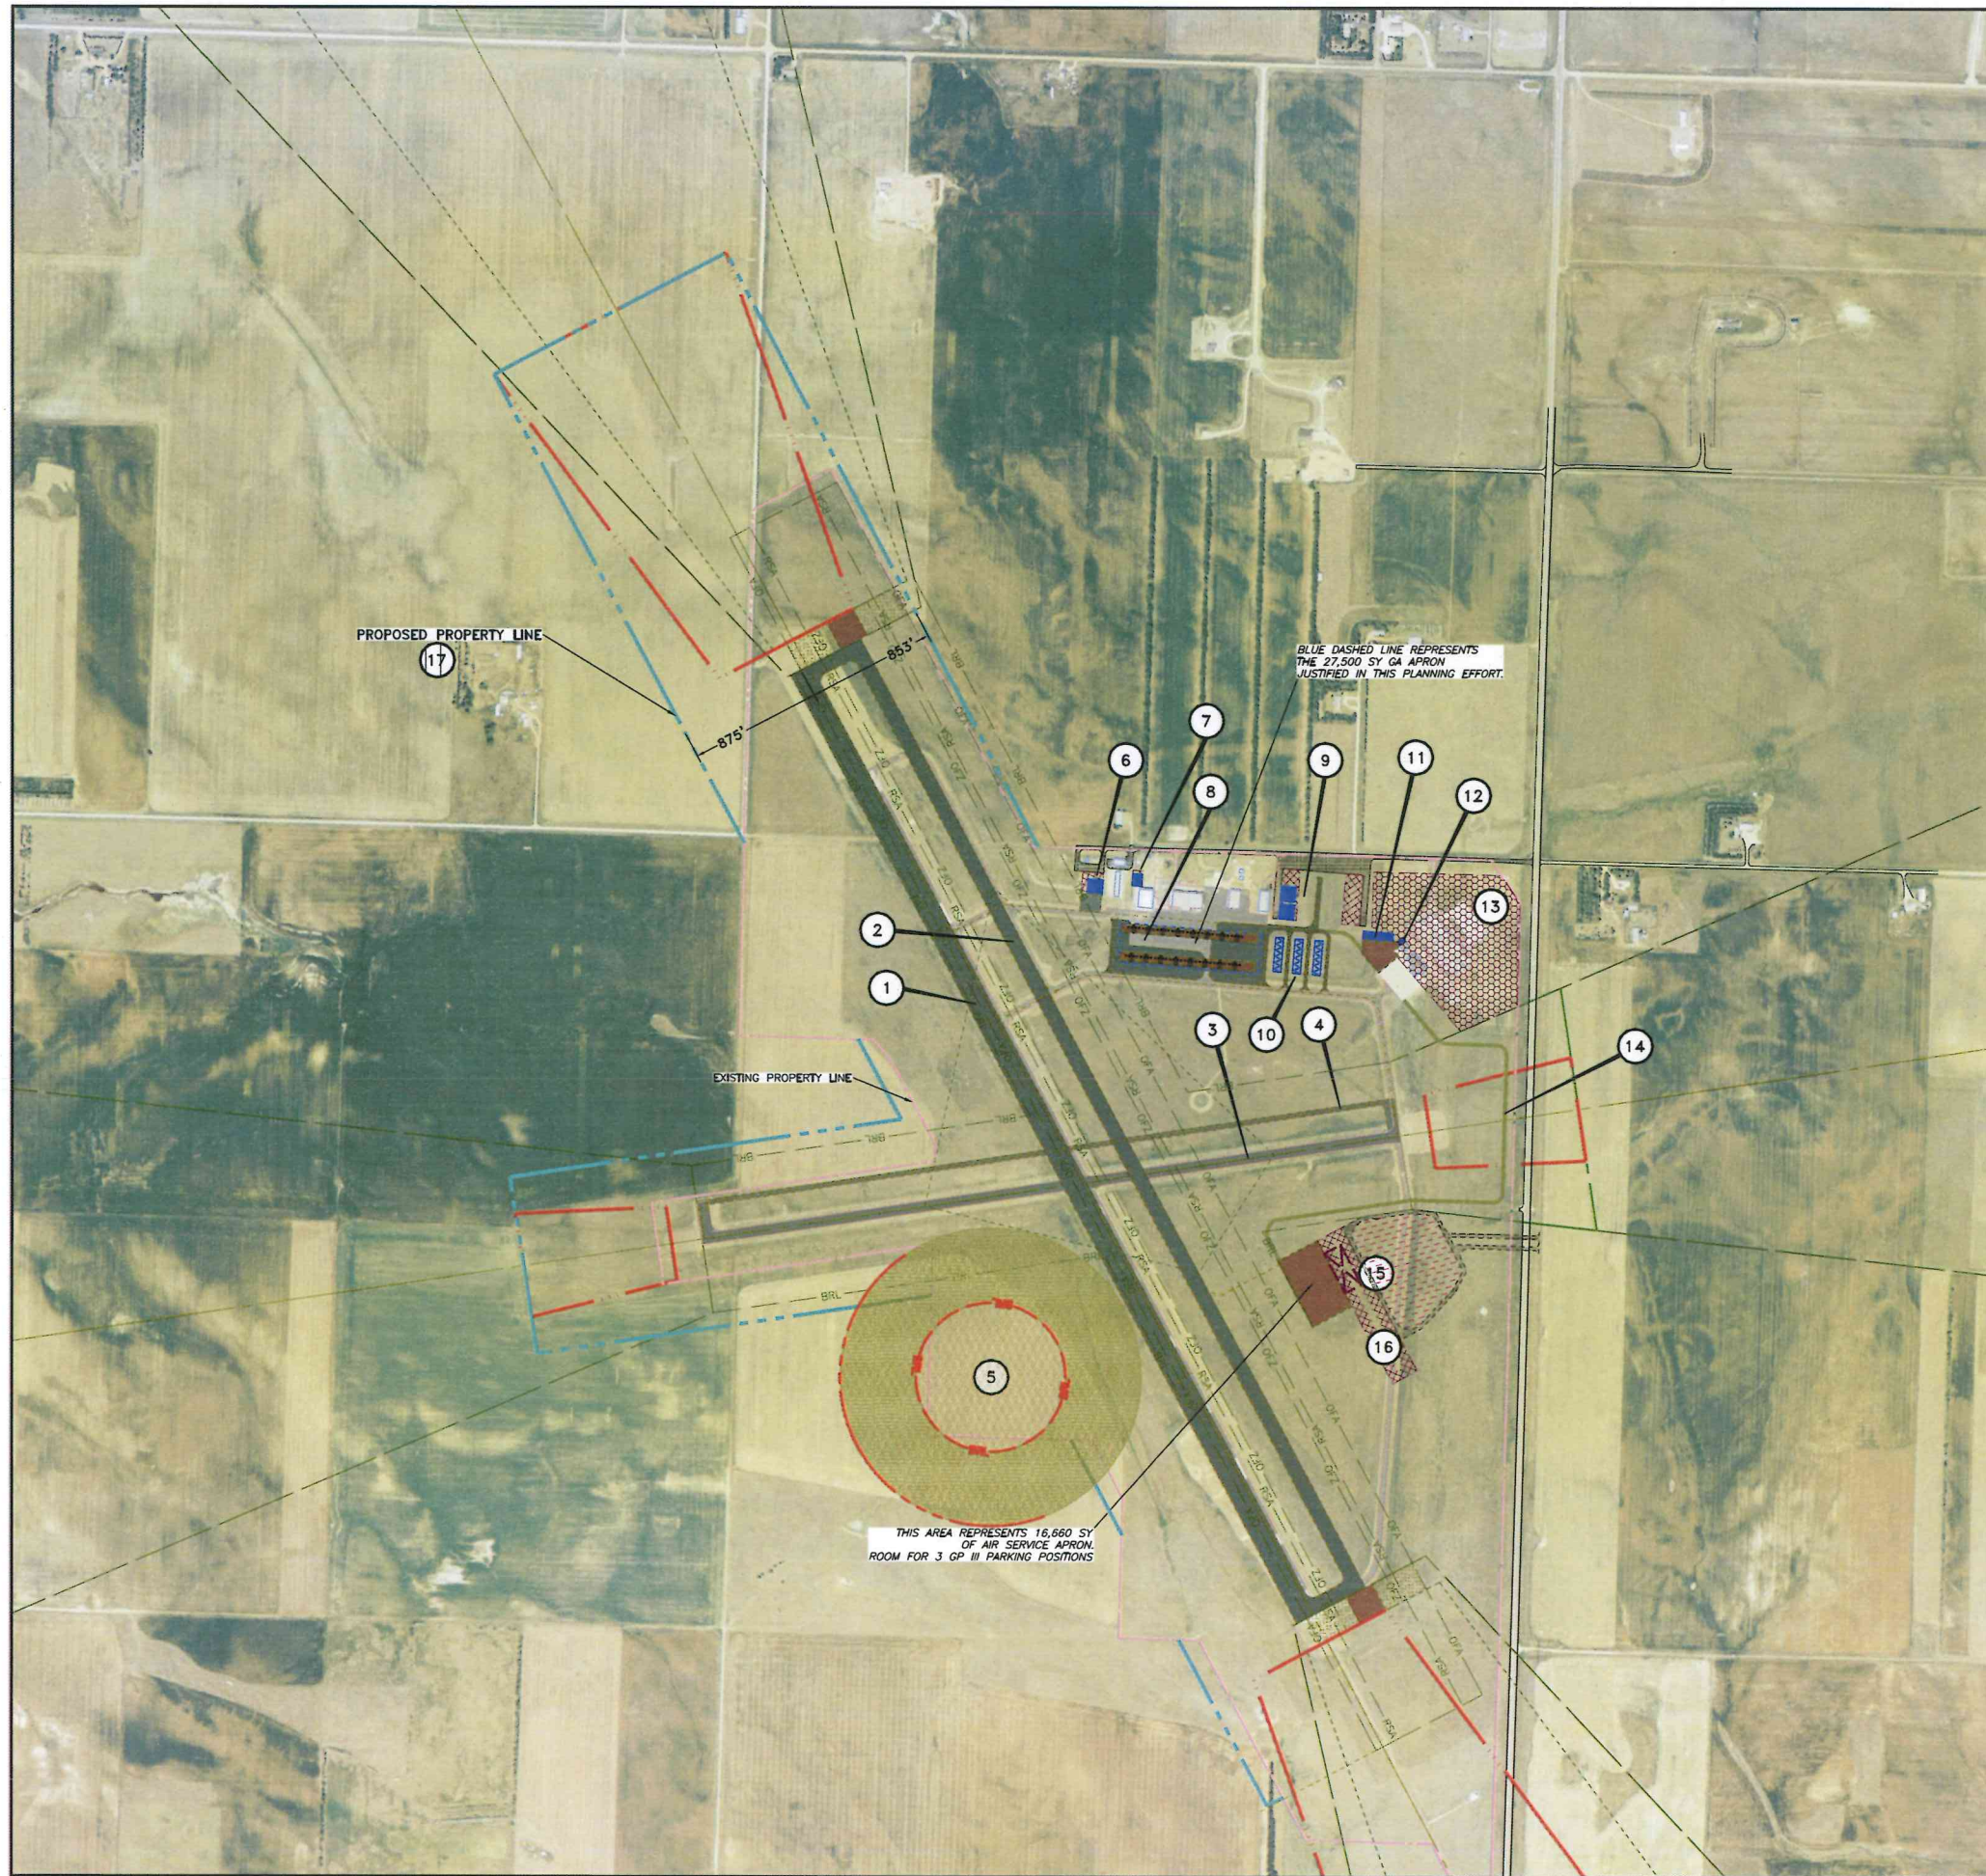
- ① 7200' x 150' GROUP III PRECISION RUNWAY CAPABLE OF SUPPORTING 150K# AIRCRAFT.
- ② 50' WIDE GROUP III PARALLEL TAXIWAY WITH 25' SHOULDERS AND MITL.
- ③ 4700' x 75' GROUP II NONPRECISION RUNWAY.

- ④ 35' WIDE GROUP II PARALLEL TAXIWAY AND MITL.
- ⑤ RELOCATED AWOS AND WIND SENSOR LOCATION WITH 500' AND 1000' BRL CLEARANCES.
- ⑥ 120' DEEP FBO LOTS WITH APRON FRONTAGE (STAGE 1 100'X100' HANGAR SHOWN)
